Appendix A

AIRSIDE FACILITY & PAVEMENT INSPECTION

A visual inspection of the existing airside facilities and paved areas at Ellington Airport was performed on October 1, 2009. This appendix summarizes the findings of the inspection, and describes the current condition and observed issues associated with each facility. Recommendations and cost estimates¹ are provided where appropriate. This information is provided in the following sections:

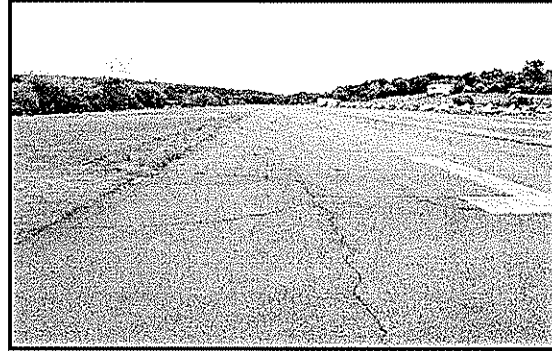
The asphalt Runway 1-19 is 1,800 feet long and 50 feet wide and underwent rehabilitation in the early 1990's. The runway has a cross slope of approximately 1%. The runway pavement is in generally fair to poor condition and is characterized by unsealed longitudinal cracking along pavement joints (½-inch to 1-inch wide); unsealed transverse (thermal) cracking spaced approximately 15 feet to 25 feet along the length of the runway (½-inch to 4-inches wide), minor edge cracking, and alligator cracking. Alligator cracking is evident on the western side of the

runway along approximately 75% of the length and on the eastern side of the runway in generally localized areas. Localized areas of settlement (up to 1-inch deep) are also evident along some cracks. Alligator cracking and settlement typically result from inadequate pavement strength and are generally caused by a loss of subgrade support due to poor drainage, asphalt stripping, and/or an inadequate pavement structure.

For the short-term, cleaning/sealing or repair of longitudinal and transverse cracks is recommended along with repair of areas of alligator cracking and settlement. Repair of severe cracks should consist of saw cutting and removing the existing pavement 6 to 12-inches on either side of the cracks; compacting or improving the existing subgrade, and patching the area with new bituminous pavement. Repair of alligator cracking and settlement should consist of removing the area of distressed pavement, improving the existing subgrade; and patching the area with new bituminous pavement. A thin bituminous overlay is recommended for consideration for all or part of the runway depending upon the resulting roughness of the patched and repaired pavement surface.

For the long-term, full-depth reconstruction of the pavement structure including improvement or replacement of the existing subgrade should be considered in conjunction with surface and subsurface drainage improvements, as necessary (see *Drainage* section for additional discussion). During the reconstruction the cross slope should be increase to 1.5%.

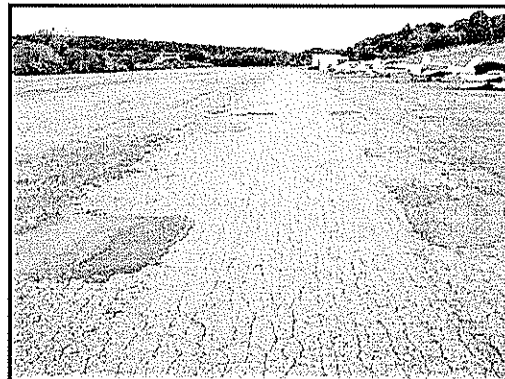
Taxiway

The taxiway runs parallel to Runway 1-19, and is approximately 1,300 feet long and is approximately 20 feet wide. The taxiway pavement has experienced complete structural failure as evidenced by severe alligator cracking over 100% of the pavement area that has resulted in several large areas of pavement deterioration. Most areas of pavement deterioration have been repaired with bituminous patches.

Due to the extensiveness of the pavement distresses, no improvements are recommended for the taxiway as a short-term fix prior to a full-depth reconstruction of the taxiway. Full-depth reconstruction of

the pavement structure including improvement or replacement of the existing subgrade should be considered in conjunction with surface and subsurface drainage improvements, as necessary (see *Drainage* section for additional discussion).

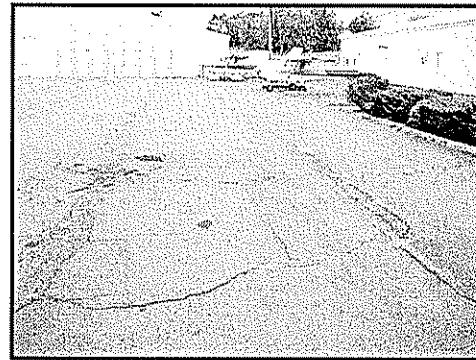
Main Apron

The main apron is comprised of several bituminous pavements of varying ages and conditions ranging from fair condition in some areas to generally poor condition. The pavement surface is characterized by unsealed longitudinal cracking along pavement joints (½-inch to more than 2-inches wide), unsealed transverse (thermal) cracking (½-inch to more than 2-inches wide), areas of localized and extensive alligator cracking, areas of localized settlement (up to 1-inch deep), areas of localized deterioration; and several bituminous patches to repair surface deterioration and utility cuts.

For the short-term, milling the existing surface and providing a bituminous overlay is recommended in conjunction with the repair of severe cracks and areas of alligator cracking and settlement. Repair of severe cracks should consist of saw cutting and removing the existing pavement 6 to 12-inches on either side of the cracks, compacting or improving the existing subgrade, and patching the area with new bituminous pavement. Repair of alligator cracking and settlement should consist of removing the area of distressed pavement, improving the existing subgrade, and patching the area with new bituminous pavement. All repairs should be completed subsequent to milling.

For the long-term, full-depth reconstruction of the pavement structure including improvement or replacement of the existing subgrade should be considered in conjunction with surface and subsurface drainage improvements, as necessary (see *Drainage* section for additional discussion).

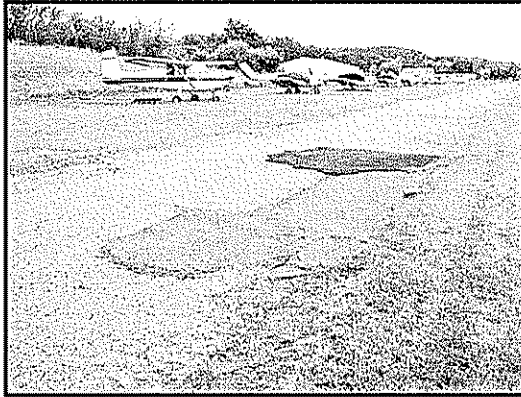
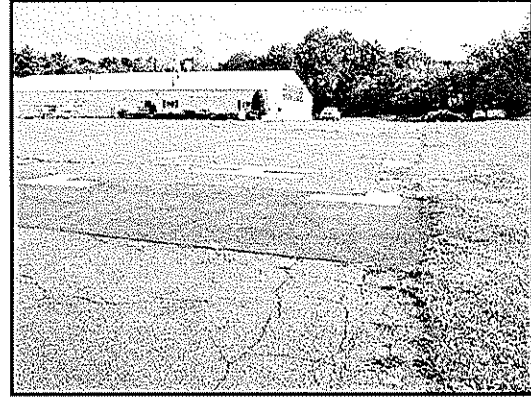
Aircraft Parking Areas

There is no paved aircraft parking area for fixed-wing aircraft at Ellington Airport. The turf area adjacent to the runway is used as a parking area for based and transient aircraft. There are approximately 22 tiedown locations across the turf area. There are five areas marked on the main

apron for helicopter parking. This area was included in the main apron inspection. Ideally, future airport improvements should include paved aircraft tiedown locations.

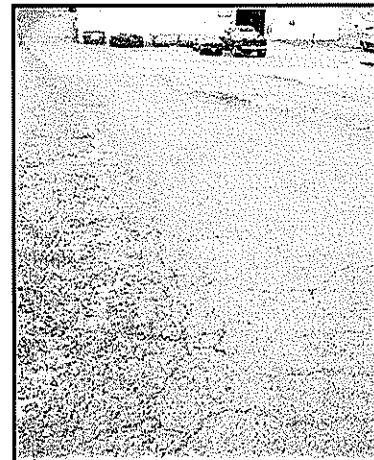
Driveways

The main airport entrance driveway is in generally good condition due to a recent rehabilitation/overlay. There are only minor issues associated with the pavement including an unsealed transverse pavement joint at the interface between the overlay and adjacent pavement, and a localized depression associated with a spot repair. The helicopter/mechanic building driveway is in generally fair to poor condition with moderate edge cracking and alligator cracking covering approximately 50% of the pavement area. Minor erosion has occurred along the west side of the driveway resulting in pavement deterioration that has been addressed with localized patching in several areas. The section of the driveway located along the east side of the helicopter/mechanic building is in generally fair condition with

several localized areas of settlement and deterioration resulting from ponding water.

For the short-term, joint sealing at the main entrance driveway and repair of deteriorated pavement areas on the helicopter/mechanic building driveway are recommended. Minor grading of the soil adjacent to the west side of the helicopter/mechanic building driveway with placement of compacted stone along its edge is also recommended to support the pavement edge and minimize future erosion.

Reconstruction of the helicopter/mechanic building driveway is recommended to improve the strength of the pavement structure and to minimize future alligator (fatigue) cracking.
